TRAINING NOTES

High Mechanism MVA

November 10, 2022 at 1626 hours
3217 San Bruno Ave

Tesla Into Building Causes Multiple Hazards

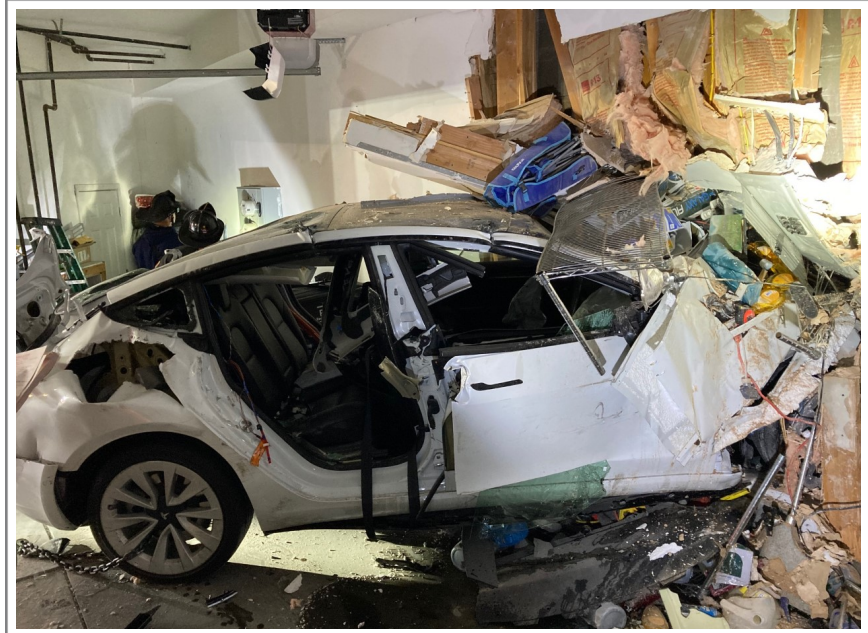
At 16:28 on November 11th, 2022, units were dispatched to an MVA vehicle into a residence. Engine 44 arrived on scene to find two vehicles involved in a high mechanism accident. Two occupants in a Tesla Model 3 were heading East Bound on Mansell towards San Bruno at a high rate of speed. The vehicle lost control, struck a parked vehicle with one occupant inside and careened into the garage of multi-family dwelling. The front half of the Tesla went through the rear wall of the garage and into an adjacent building.

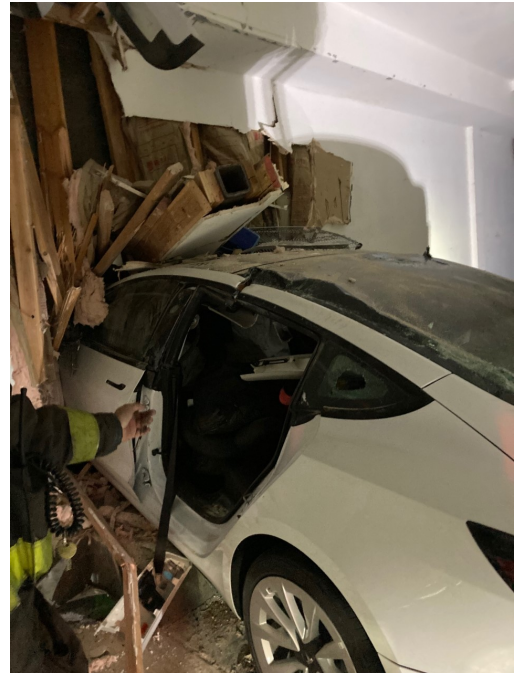
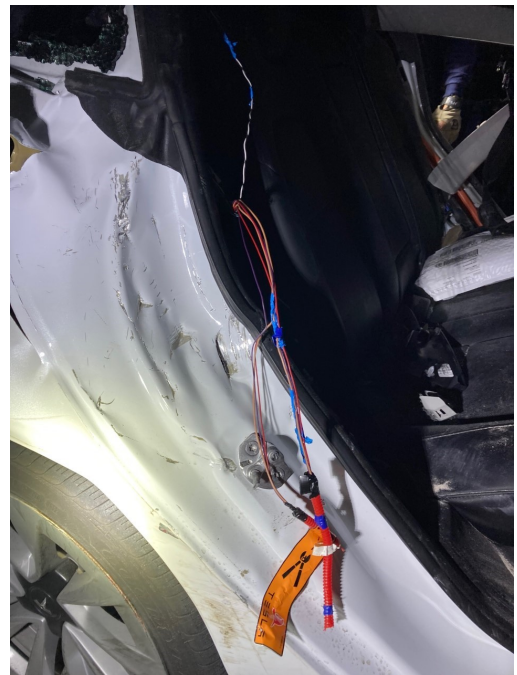
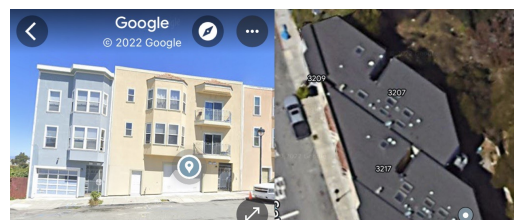
The unique design of the buildings involved were identified during the search of the buildings. The layout of the buildings was at a 45-degree angle. When the Tesla crashed into the garage, the front half of the vehicle went through the rear wall and into an apartment unit in the Bravo Exposure.

The Tesla needed to have all electrical hazards shut off prior to moving the vehicle from the structure. The primary electrical shutoff for this model Tesla was in the main engine area at the front of the vehicle. This area was not accessible due to the location of the hood in the Bravo Exposure. Rescue Squad 1 was able to locate and disconnect the secondary electrical shutoff in the C Post of the Passenger side of the vehicle.
