TRAINING NOTES

3rd Alarm 1604 McAllister

August 23, 2022 1604 McAllister San Francisco

1604 McAllister 3rd Alarm

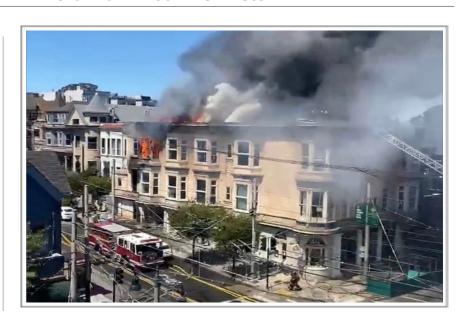
On August 23, 2022, Box 4151 was struck at 1604 McAllister for a fire in the building. Responding units declared a working fire at the three-story type 5 corner building. On arrival, heavy fire was venting from the second floor alpha/bravo corner window. The building posed many challenges due to its unique layout and unassuming construction.
